TS-PIC-89790  
September 1989

AERIAL PHOTOGRAPHIC ANALYSIS OF THE MADISON MINE COMPLEX

Fredericktown, Missouri

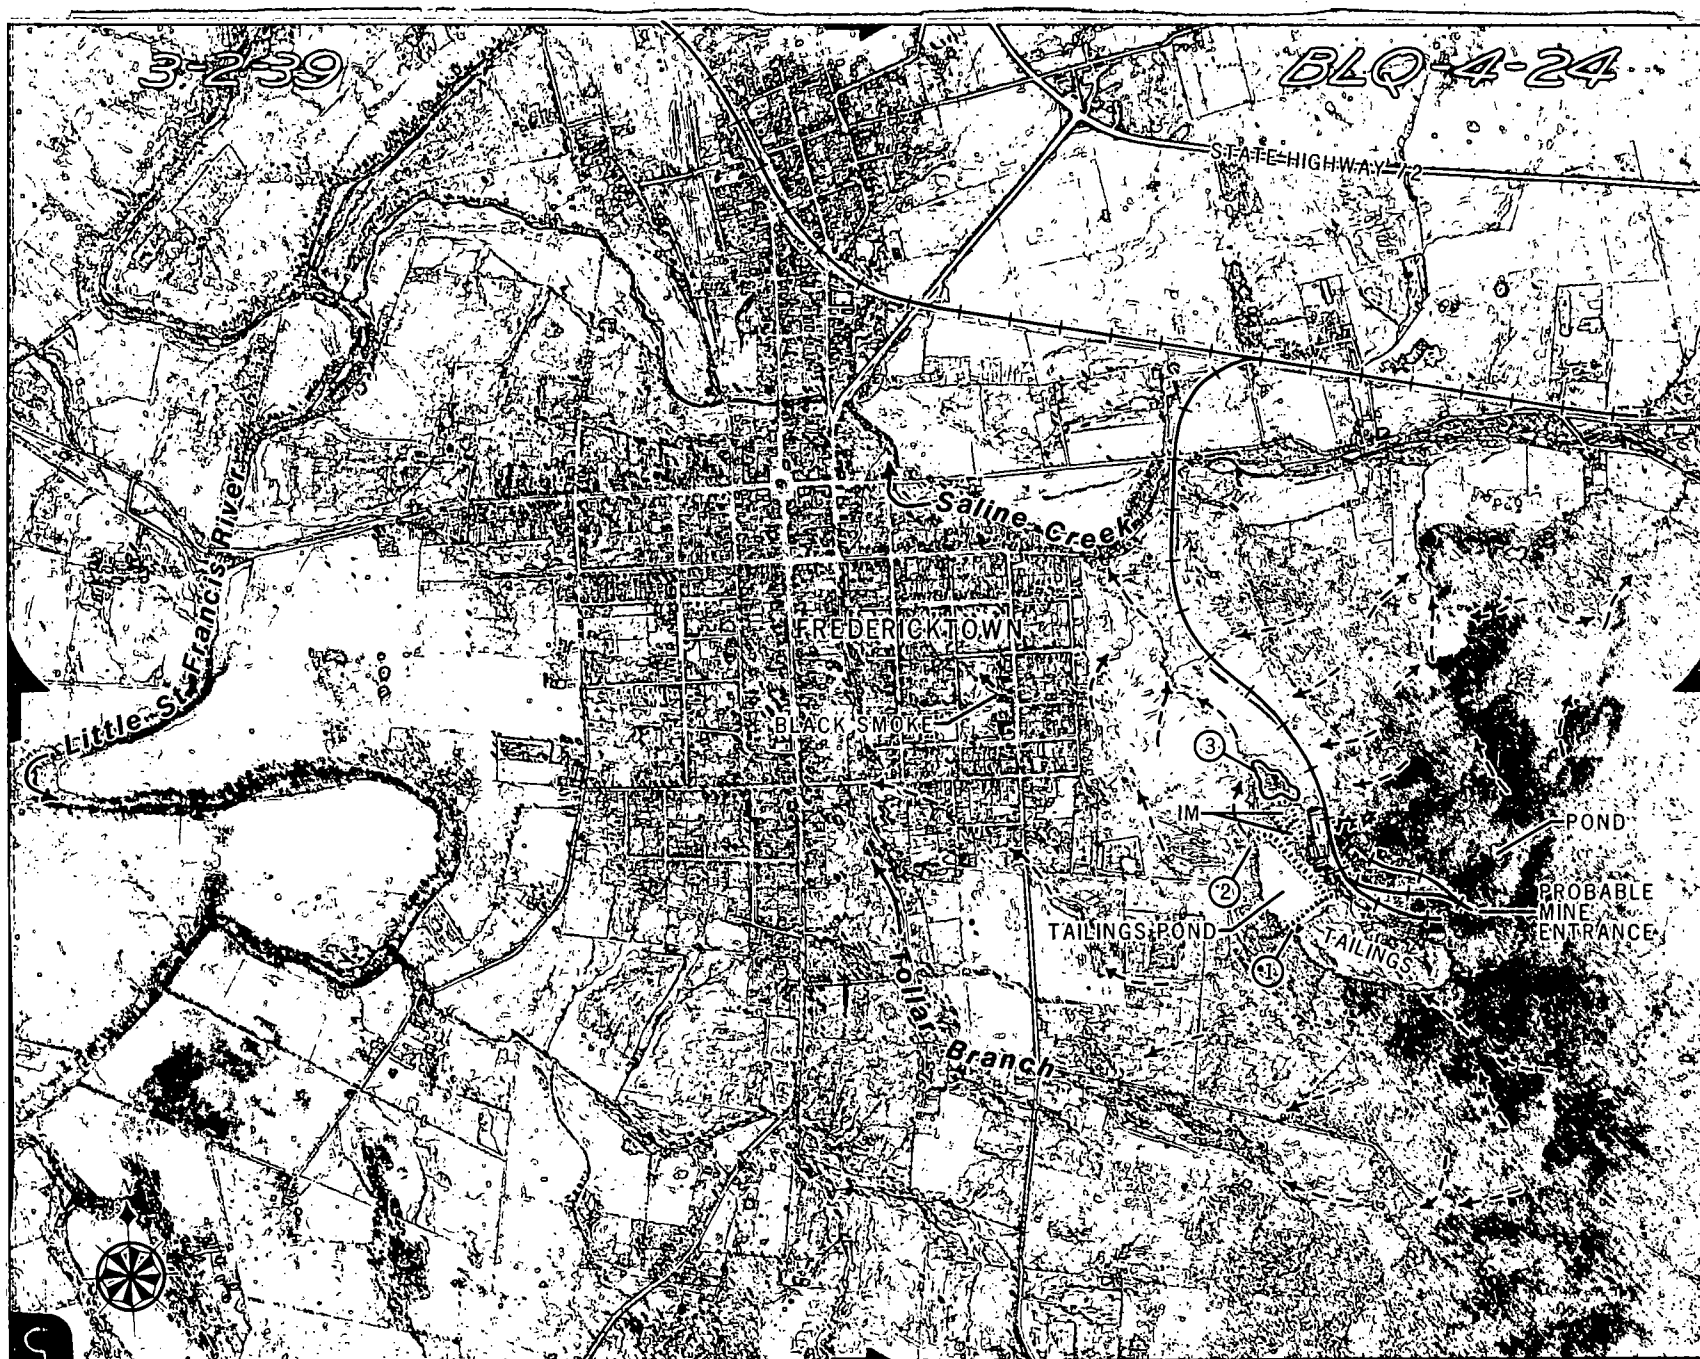
Figure 3. Madison Mine, March 2, 1939. Approximate scale 1:21,300.

This photo shows the Madison Mine to be located southeast of Fredericktown, which is located in the northeast portion of Madison County, approximately 70 miles south of St. Louis, Missouri. The site, which is both road and rail served, has no visible security. There are tailings and a tailings pond located in the drainage pattern on the south and southwest side of the ore processing buildings. Annotation 1 is the release point where excess liquid is allowed to flow from the tailings into the tailings pond. Annotation 2 is an overflow ditch that directs excess liquid from the tailings pond into an unnamed intermittent stream that leads directly to Saline Creek. There are two small impoundments located immediately north of the tailings pond that are designed to retain runoff from the ore processing area. Immediately north of the impoundments at Annotation 3 solid waste is being dumped along the unnamed stream.

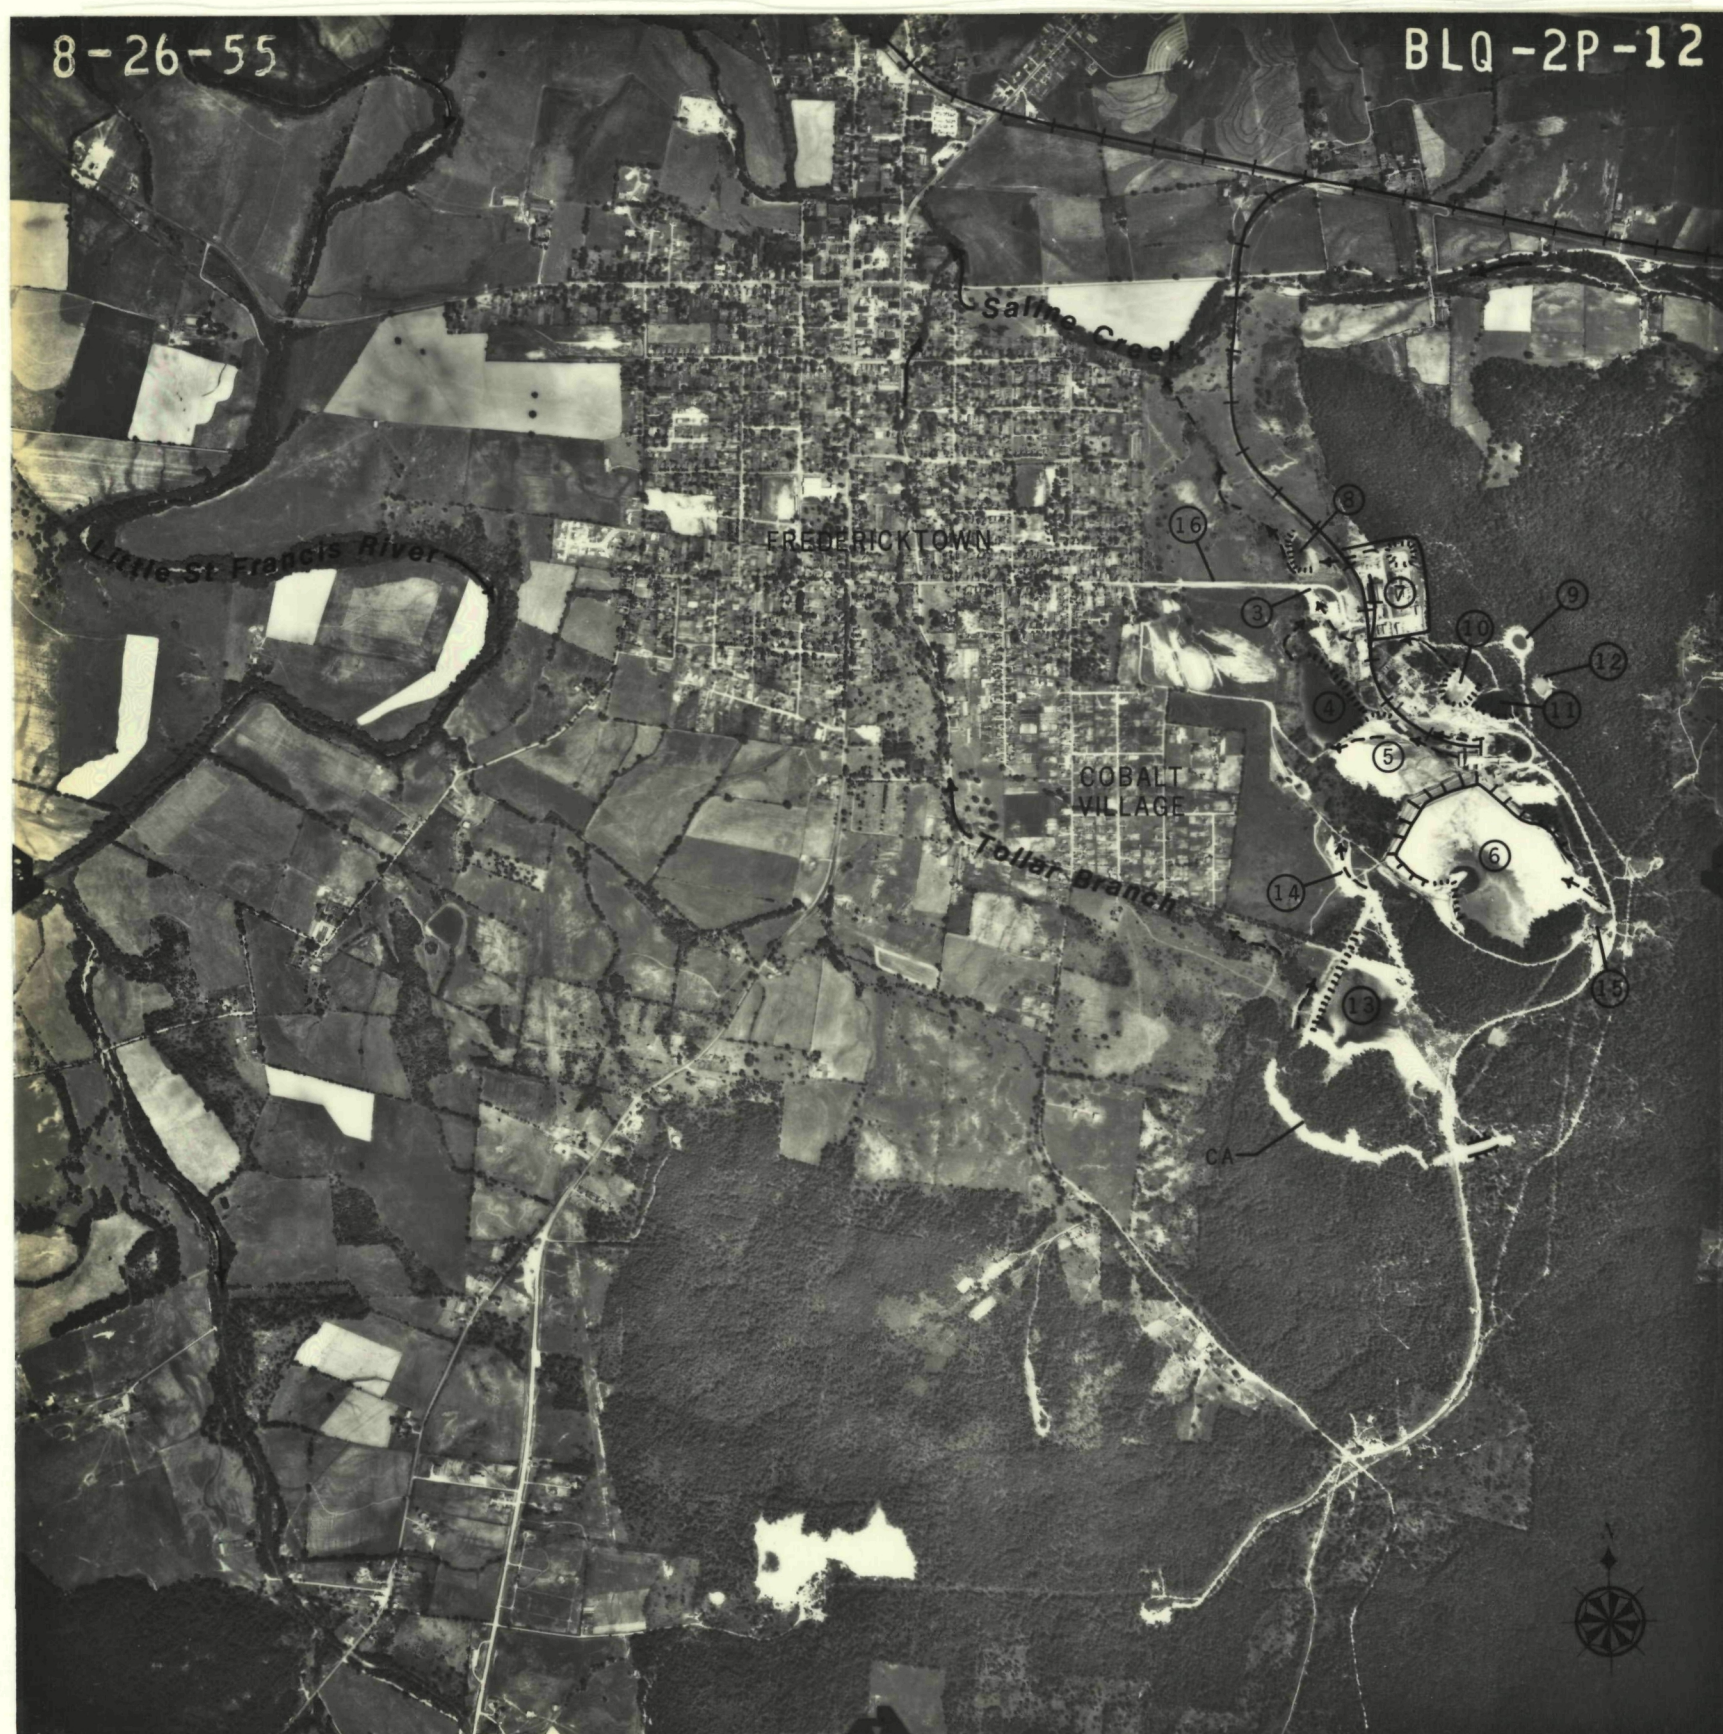
Figure 4. Madison Mine, August 26, 1955. Approximate scale 1:21,300.

Extensive changes have occurred at the Madison Mine since the photo coverage of March 2, 1939, including the presence of new ponds, impoundments, tailings, and an additional ore processing area. Some of the older facilities have been demolished.

There are no signs of the solid waste previously located at Annotation 3. This area is now level and barren. The only change to the tailings pond at Annotation 4 is the build-up of sediment at its south end where liquid from the tailings of Annotation 5 are released into the pond. The stained drainage pattern atop the tailings of Annotation 5 shows that liquid coming from the buildings at the end of the rail line is traveling into the pond at Annotation 4. The new tailings at Annotation 6 has a pipeline extending along its northeastern and northwestern edges that originates in the building at the end of the rail line. The new mill works that has been constructed at Annotation 7 has four vertical tanks that are uncontained and one that is contained. There is a small drainage ditch along the northern edge of this area that leads to a new impoundment at Annotation 8. Annotation 9 is a new pond that appears to be lined. The new unlined ponds located at Annotations 10 and 11 are both filled to capacity; Annotation 10 with sludge and Annotation 11 with a dark colored liquid. There has been no visible change to the pond at Annotation 12. An earthen dam has been built across the drainage into Tollar Branch creating the impoundment at Annotation 13. A drainage ditch (Annotation 14) is being excavated from the north end of this area and leading into the tailings at Annotation 5. There is a cleared area along the side of the hills south of the impoundment that leads to another earthen dam under construction. Annotation 15 is the location of a small group of newly erected buildings, and Annotation 16 is the new access road to the Madison Mine complex.

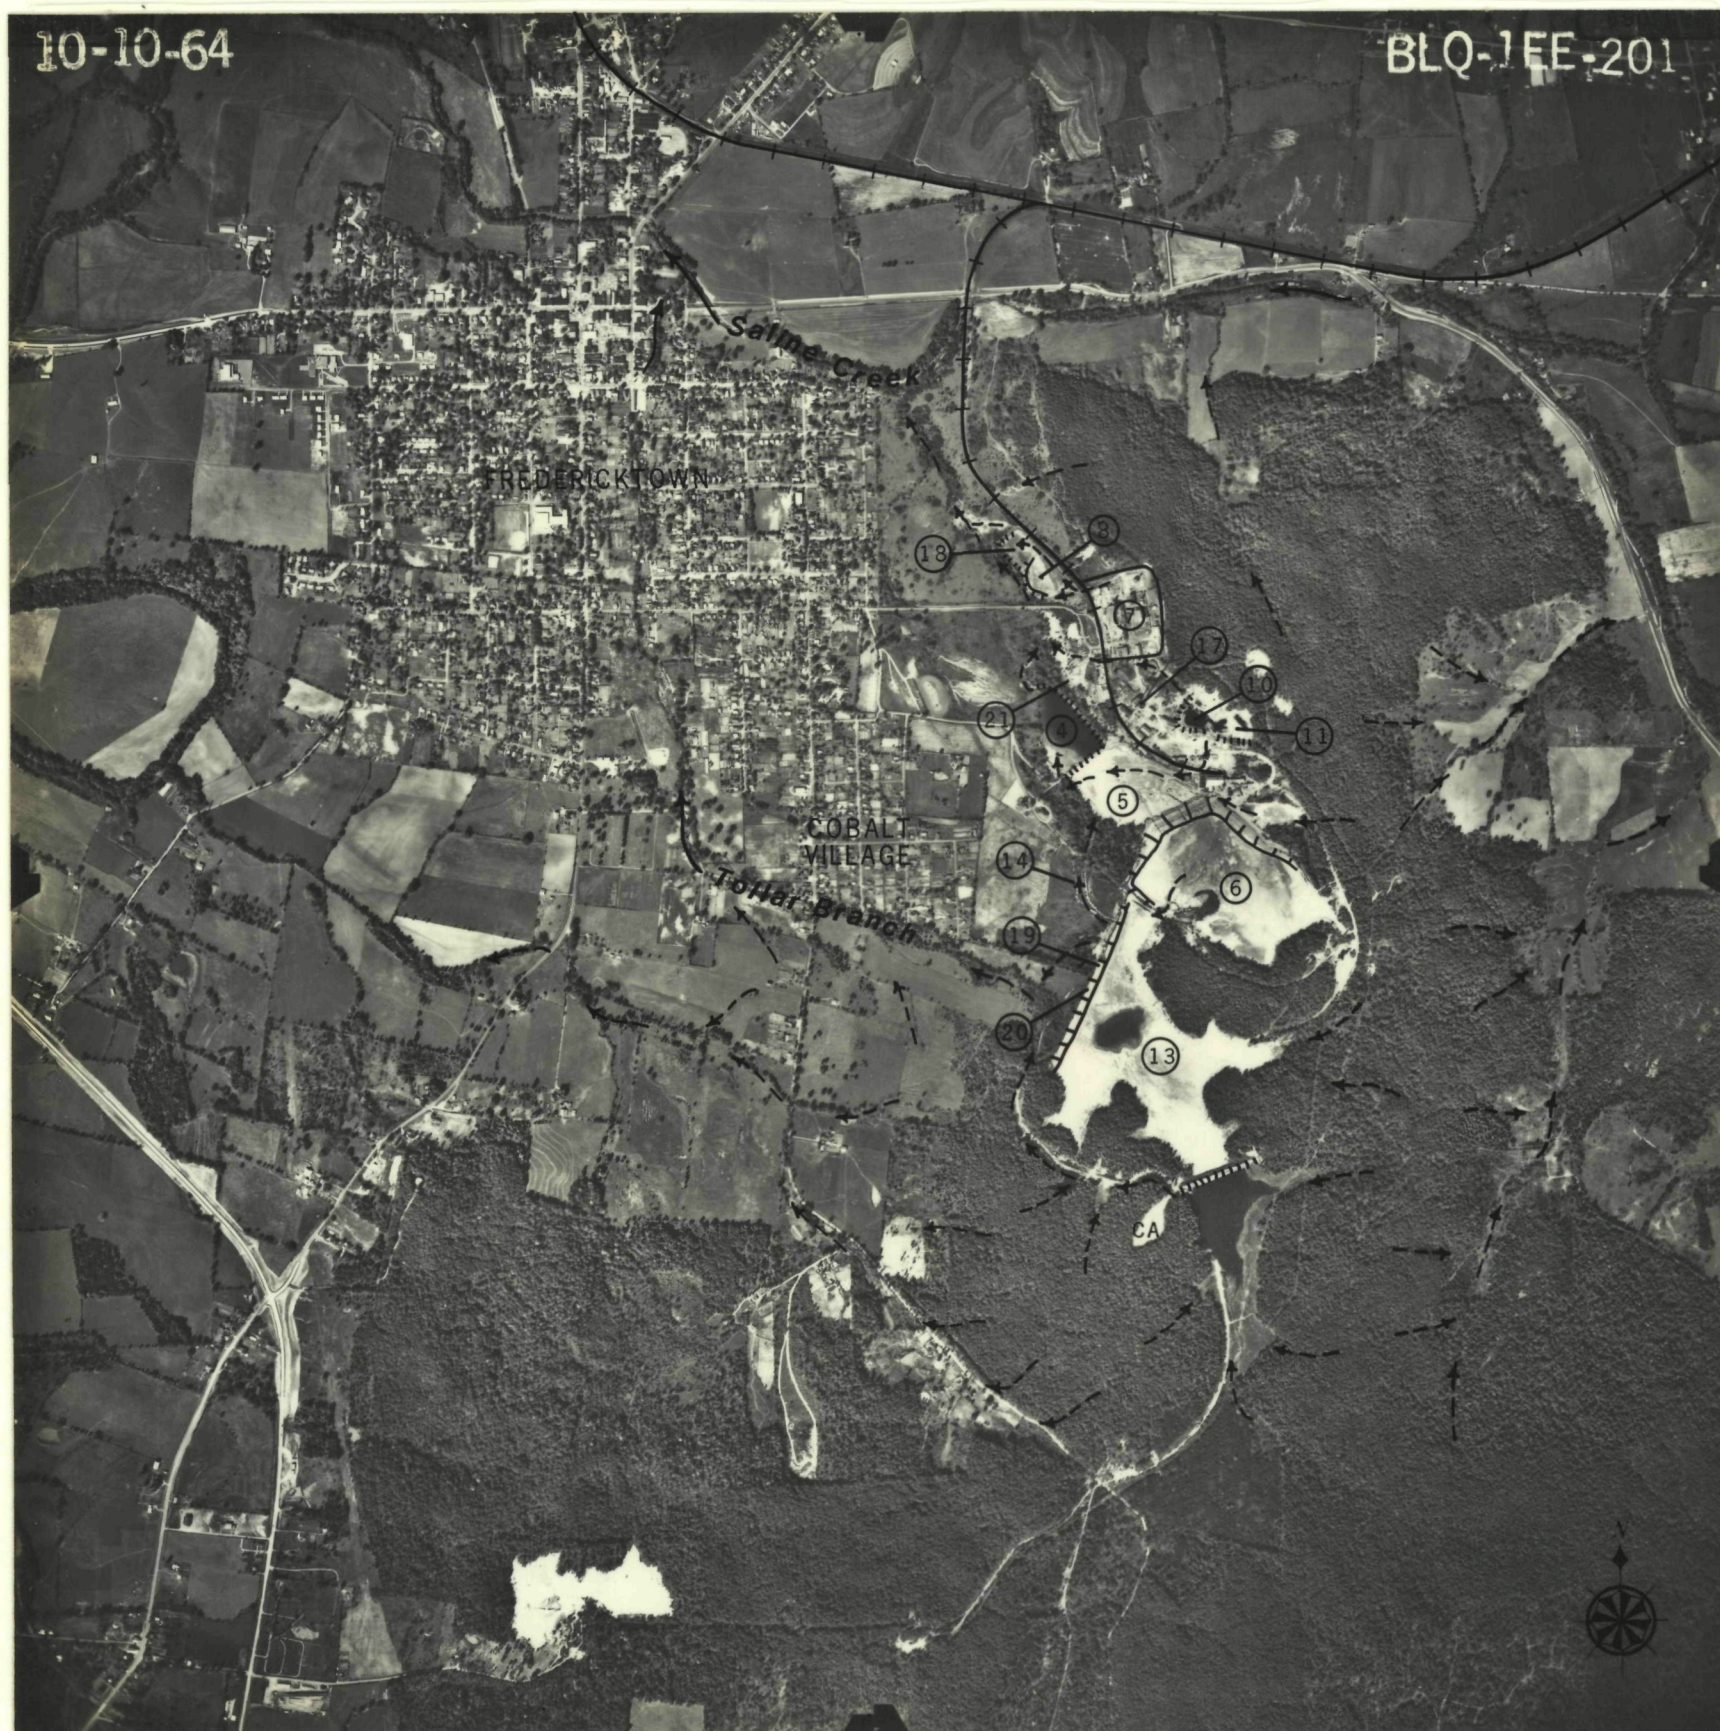
Figure 5. Madison Mine, October 10, 1964. Approximate scale 1:21,300.

The quantity of sediment at the south end of the tailings pond (Annotation 4) has increased, and appears to be the result of runoff passing through the tailings of Annotation 5. The build-up at the east end of the tailings (Annotation 5) appears to be the accumulation of erosion that is occurring along the face of the tailings located at Annotation 6. The drainage ditch leading from the mill works of Annotation 7 now passes around the south side of the impoundment at Annotation 8, which is filled with sludge, and enters the stream leading to Saline Creek. This ditch forks at the railroad tracks and the northern fork leads to a new impoundment at Annotation 18. There is a visible trail of previous releases from the northern corner of this impoundment that leads into the stream leading to Saline Creek. Most of the sludge previously located in the pond at Annotation 10 has been removed. There is a trail leading from this pond's northern edge that appears to be the track of previously released liquid which traveled to the stream that leads to Saline Creek. The southwestern wall of the pond at Annotation 11 appears to have been breached and temporary repairs made. There are piles of what appears to be sludge all along the southwestern walls of the ponds at Annotations 10 and 11, and there is a trail of staining leading from the breach area, through the tailings of Annotation 5 to the tailings pond at Annotation 4. The staining also enters the drainage system leaving the site. The earthen dam has been completed at the south end of the tailings located at Annotation 13. A drainage ditch has been dug from the western edge of this dam, around the south side of the tailings to Tollar Branch. Along the face of these tailings are located an area of seepage (Annotation 19) and an area of erosion (Annotation 20). Both of these areas lead directly to Tollar Branch. The drainage ditch (Annotation 14), leading from the face of the tailings to the tailings at Annotation 5, has been completed. Annotation 21 is an area previously occupied by small impoundments where a small amount of solid waste dumping has occurred.

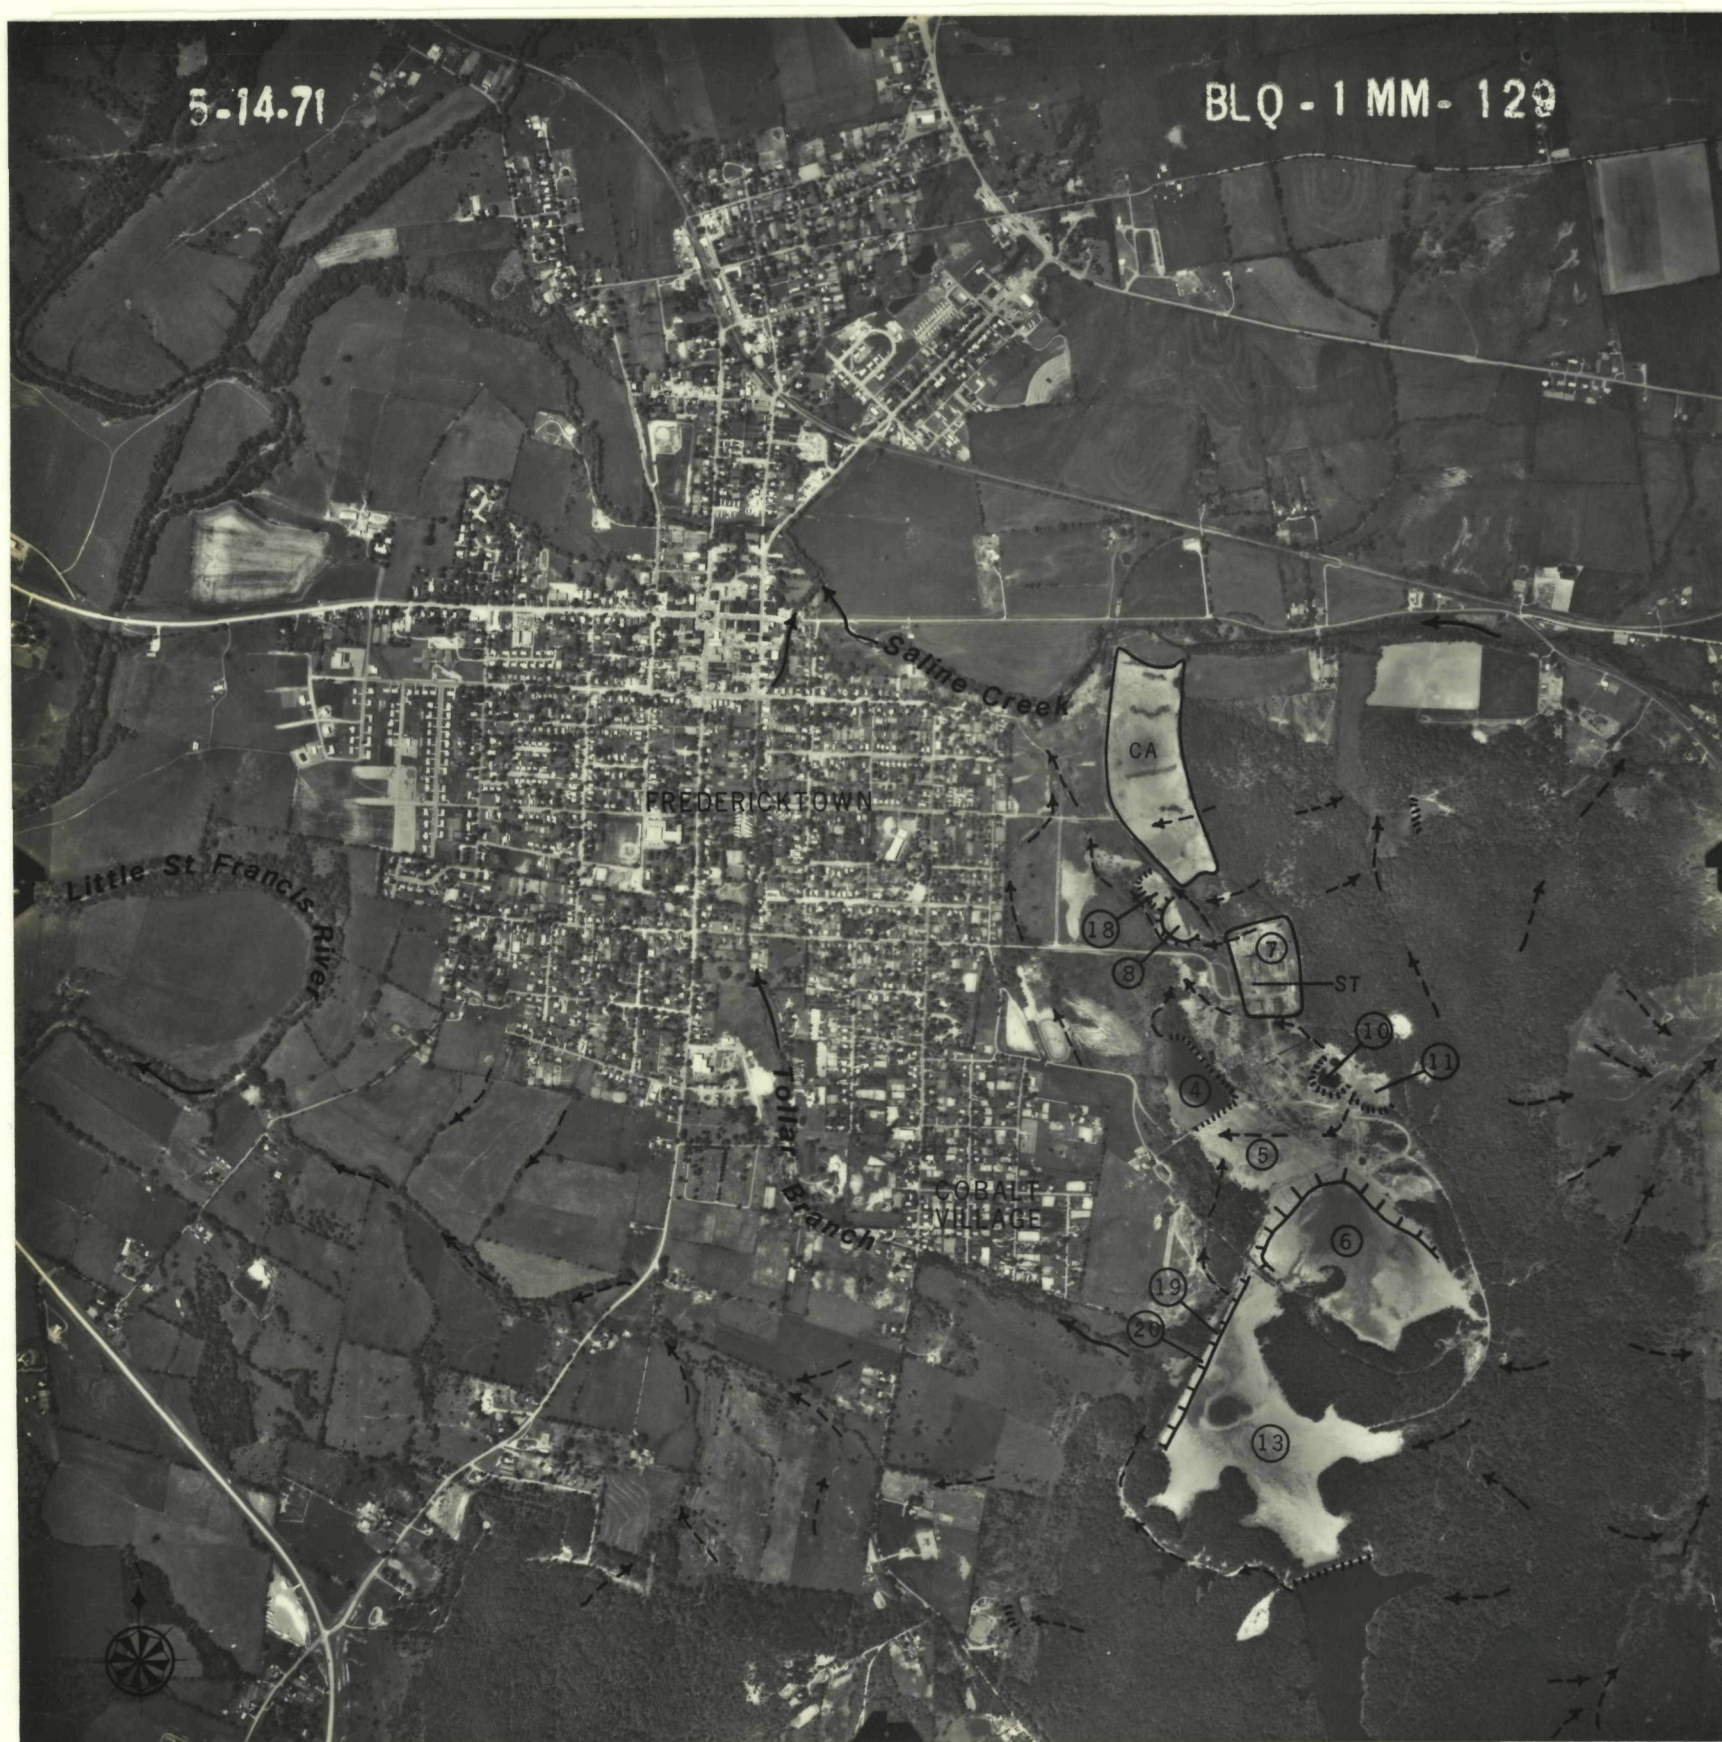
Figure 6. Madison Mine, May 14, 1971. Approximate scale 1:20,100.

All of the buildings at the Madison Mine complex except those located at Annotation 7, have been demolished. All of the tanks have been removed from the area of Annotation 7, and there is visible staining at the south end of the largest building in this area. The impoundments located at Annotations 8 and 18 appear unchanged, as do the tailings pond and tailings of Annotations 4, 5, and 6. There is a breach in the wall of the pond at Annotation 11 and a trail showing the ponds contents traveled through the tailings of Annotation 5 to the tailings pond of Annotation 4. Along the face of the tailings (Annotation 13) are still located an area of seepage at Annotation 19 and an area of erosion at Annotation 20. The area between the erosion activity and Tollar Branch is now barren.

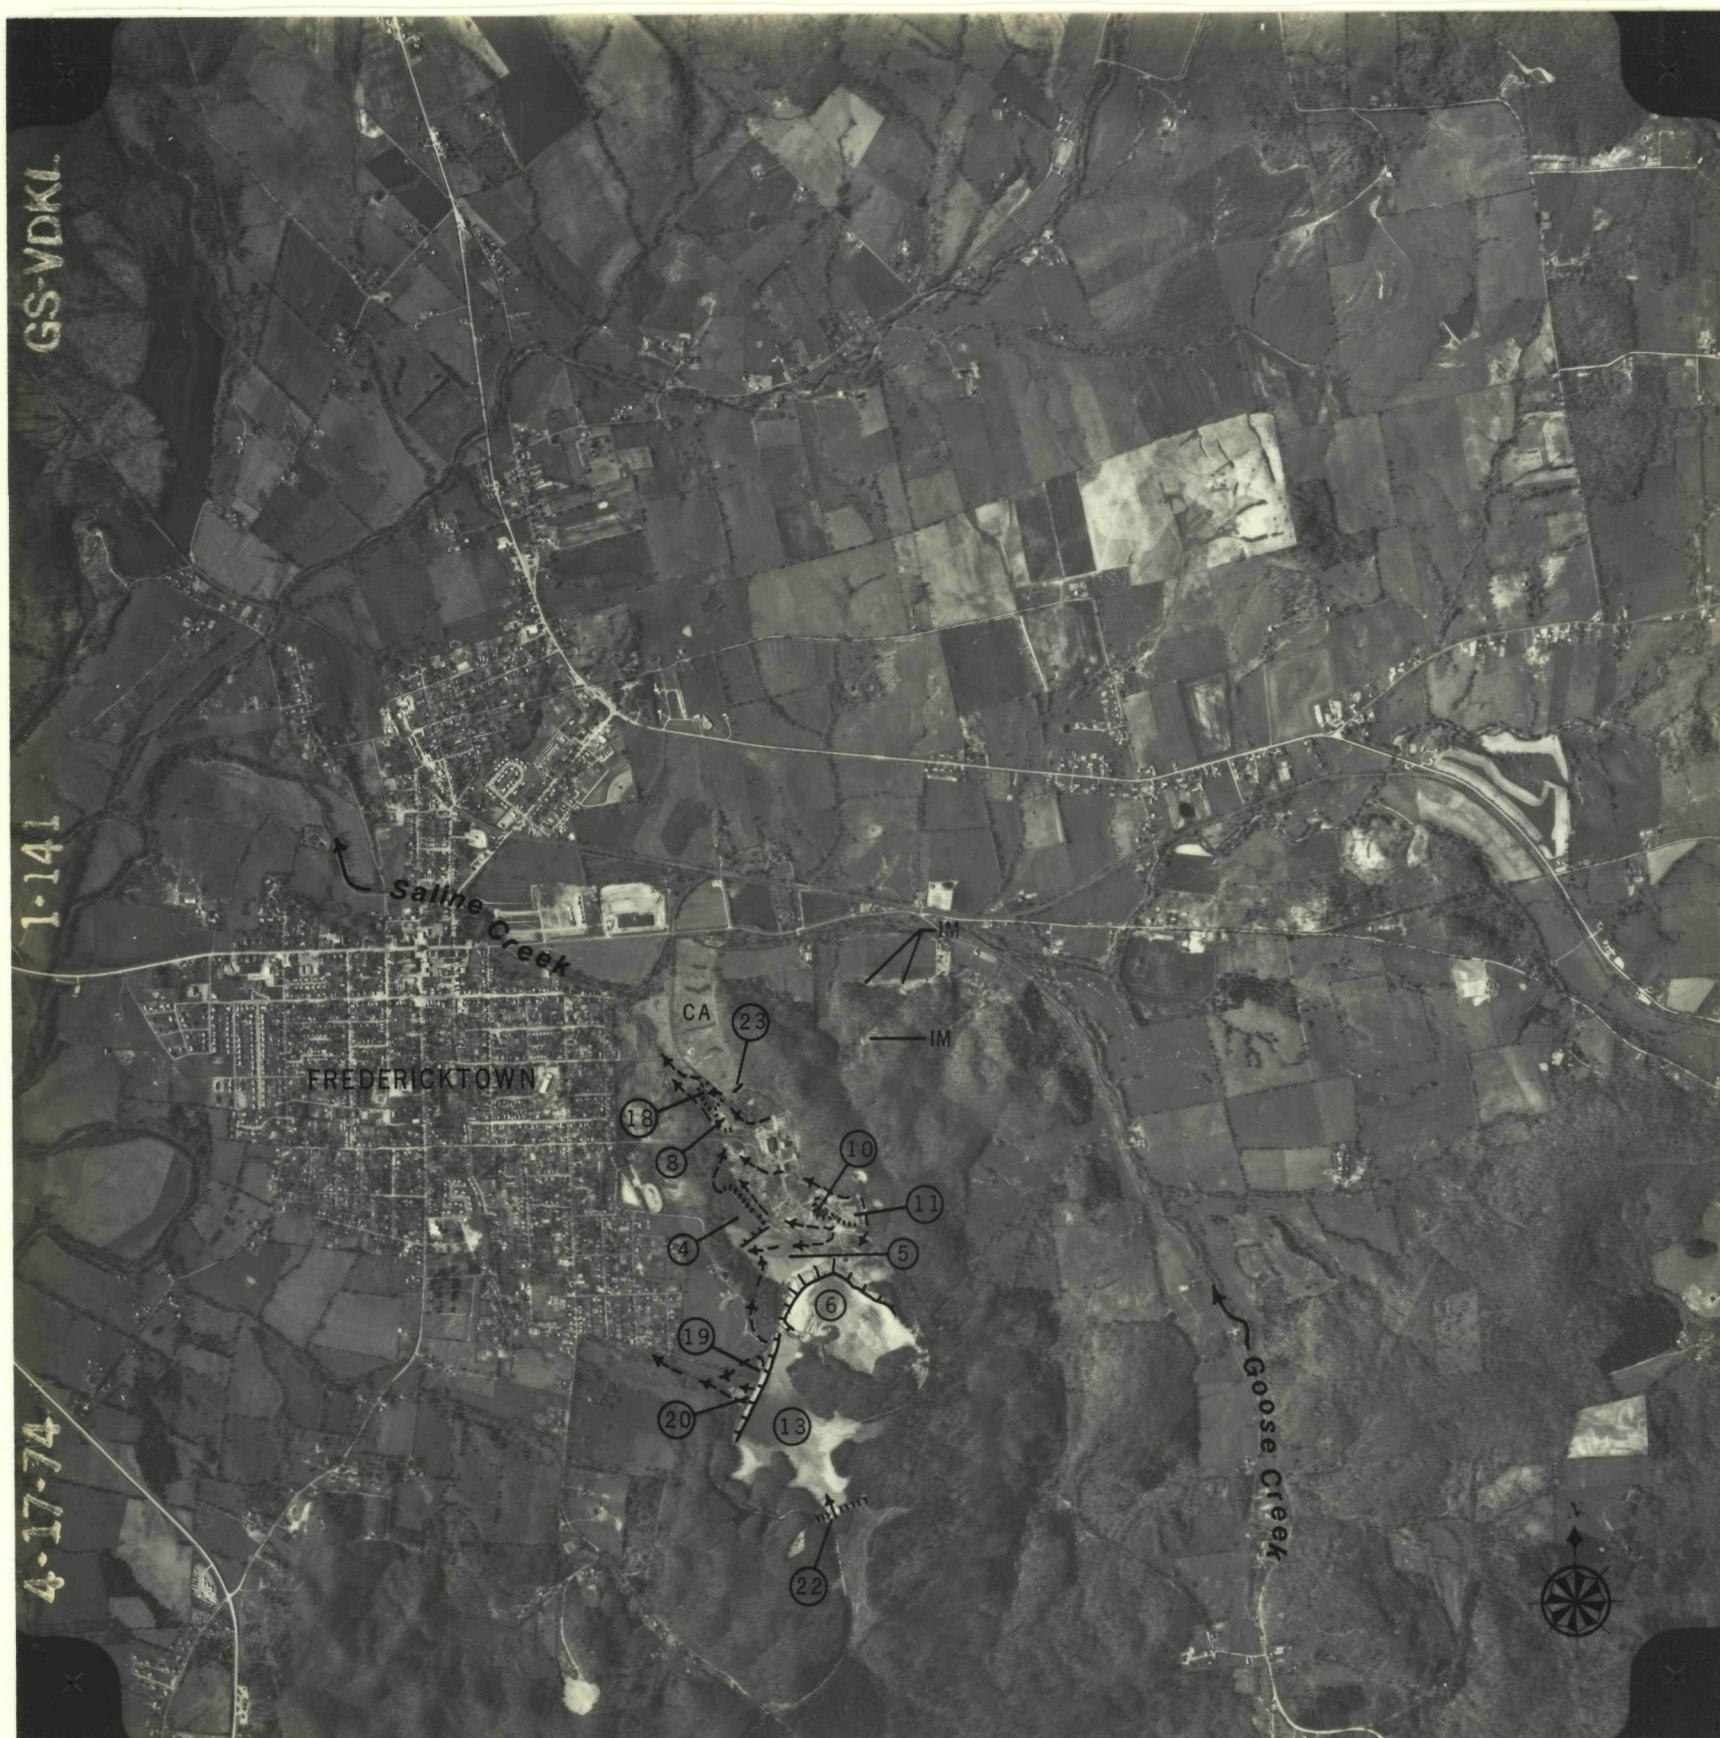
Figure 7. Madison Mine, April 17, 1974. Approximate scale 1:33,200.

There has been very little change at the Madison Mine complex since the photo coverage of May 14, 1971 (Figure 6). The erosional activity along the face of the mine tailings of Annotation 6 has continued to fill the tailings of Annotation 5 that releases excess liquids into the tailings pond (Annotation 4). A majority of the sludge previously located in the impoundment at Annotation 8 is no longer visible. The impoundment located at Annotation 18 is partially filled with liquid that may have come from the mill works area (Annotation 7) via the drainage ditch. To the east of this impoundment at Annotation 23 is located a trench that is possibly being used for waste disposal. Fill material is being dumped into the north end of the pond located at Annotation 10. The breach in the southern wall of the pond at Annotation 11 has again been temporarily repaired, and there is mounded material inside the pond adjacent to a pit that has been excavated adjacent to the repaired breach. A diversionary ditch has been excavated on the uphill side of both ponds to direct runoff around the ponds and into the drainage system leading to Saline Creek. A majority of the tailings at Annotation 13 are submerged by water, previously held by the earthen dam at the south end of the tailings. An intentional cut appears to have been made in the dam allowing all the water to escape. The seepage is still visible on the face of these tailings at Annotation 19, and the erosion activity at Annotation 20 has spread.

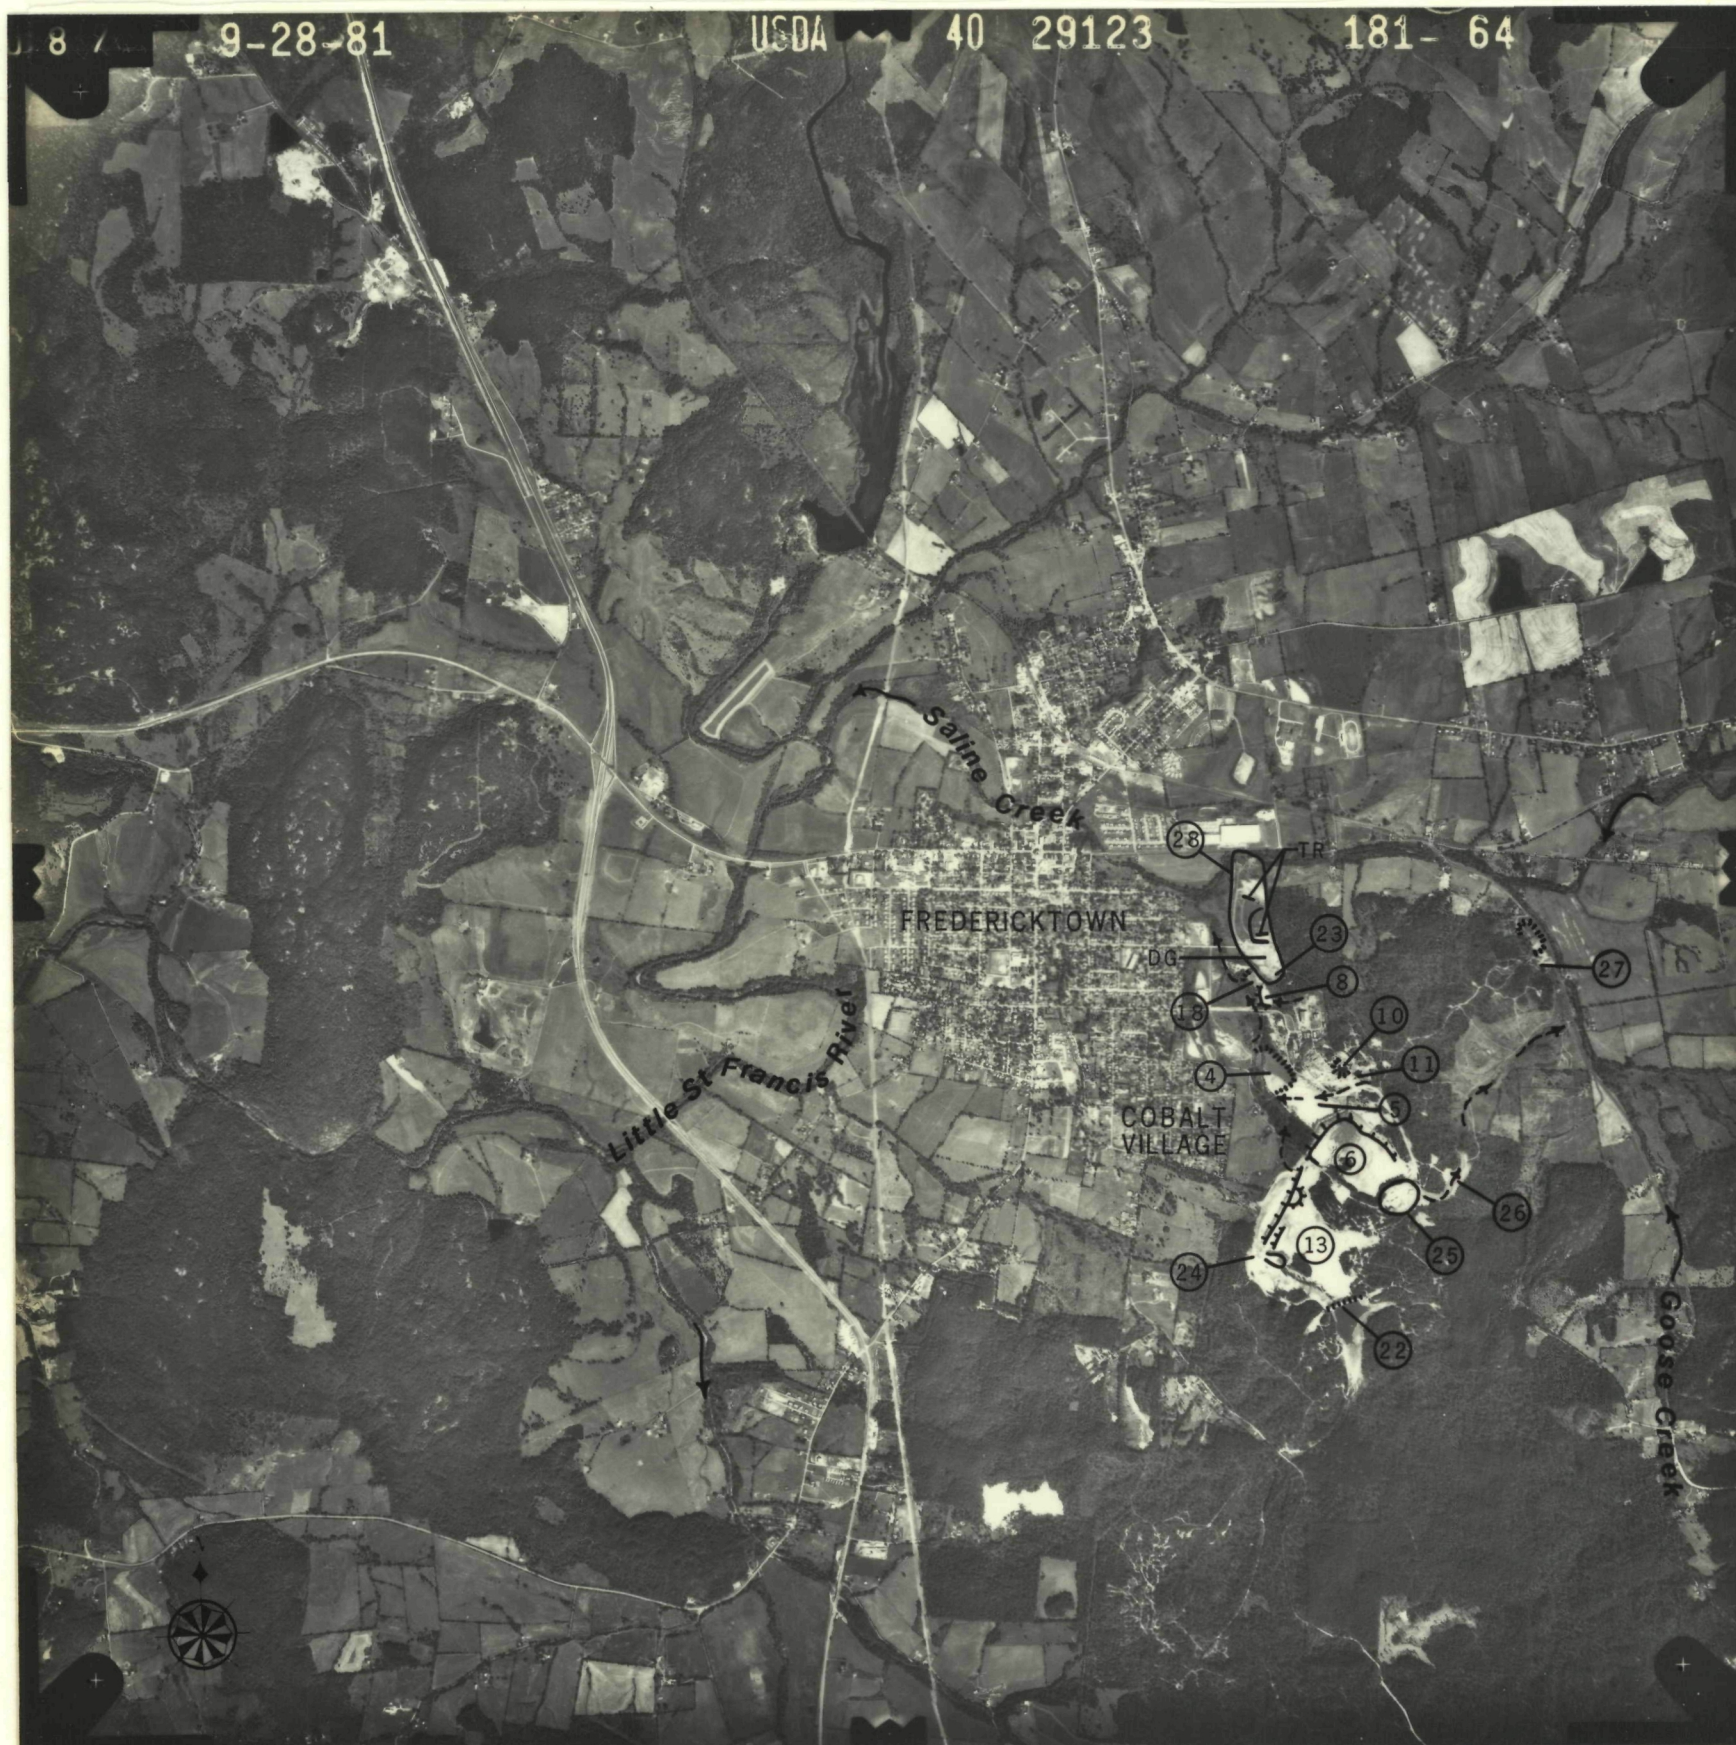
Figure 8. Madison Mine, September 28, 1981. Approximate scale 1:43,400.

The impoundments located at Annotations 8 and 18 and the pond at Annotation 10 have the same basic appearance as shown on the photo coverage of April 17, 1974 (Figure 7). There is now a second breach in the southern containment wall of the pond located at Annotation 11. There is a trail left by the liquid released through this breach that travels through the tailings of Annotation 5 to the entrance of the tailings pond at Annotation 4. The erosion activity has continued along the face of the tailings at Annotation 6 where there are now many deep gullies. There has been a new group of four buildings constructed on a small knoll at Annotation 25, and a discharge pipe coming from underground empties into the newly constructed drainage ditch (Annotation 26) which empties into the natural drainage system leading northeast to Saline Creek. Extensive modifications are in progress on the face of the tailings located at Annotation 13. The earthen dam at Annotation 22 has been repaired and there are pieces of heavy equipment located at Annotation 24. Annotation 27 is a mine entrance and an empty pond that are directly linked to the site by dirt roads leading from the mine entrance to ponds at Annotations 10 and 11, and the newly constructed buildings at Annotation 25. There are three trenches located in the area of Annotation 28 and the trench previously reported at Annotation 23 has been filled. The disturbed ground in the southern portion of this area indicates more trenches may have been previously located here.
